# A Twenty-Year Report On The Illinois Continuously Reinforced Pavement

RESEARCH AND DEVELOPMENT  
REPORT NO. 17

October 1967

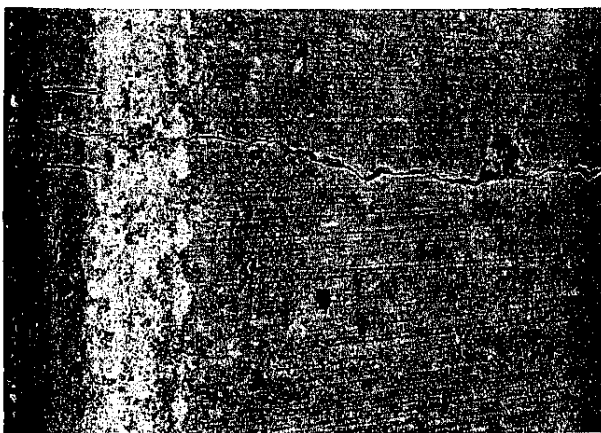
The pavement surface at most of the cracks now shows occasional slight spalling. The amount and severity of the spall is related to the percentage of longitudinal reinforcement, and is most pronounced in the sections having 0.3 percent of steel. Little increase in spall has taken place after the first few years, and that which is visible after 20 years of service does not detract appreciably from the general appearance of the pavement, nor require any maintenance. The cracks are not visible to occupants of vehicles traveling the pavement at ordinary speeds. Photographs of a typical transverse crack in each of the sections of 7-inch pavement taken in 1950, 1957, and 1967 are shown in Figure 6.

Except at a few cracks in the 0.3 percent longitudinal steel sections where excessive movement and obvious failure have taken place, the performance of the pavement at transverse cracks of all sections must be considered to be satisfactory. The structural continuity of the pavement has been maintained. While the crack openings are such that evidence of the infiltration of very fine material that might be speculated to have been moisture-deposited has been found, no signs of serious structural damage attributable to this source have been observed.

Figure 6. Typical transverse cracks in 7-in. sections.

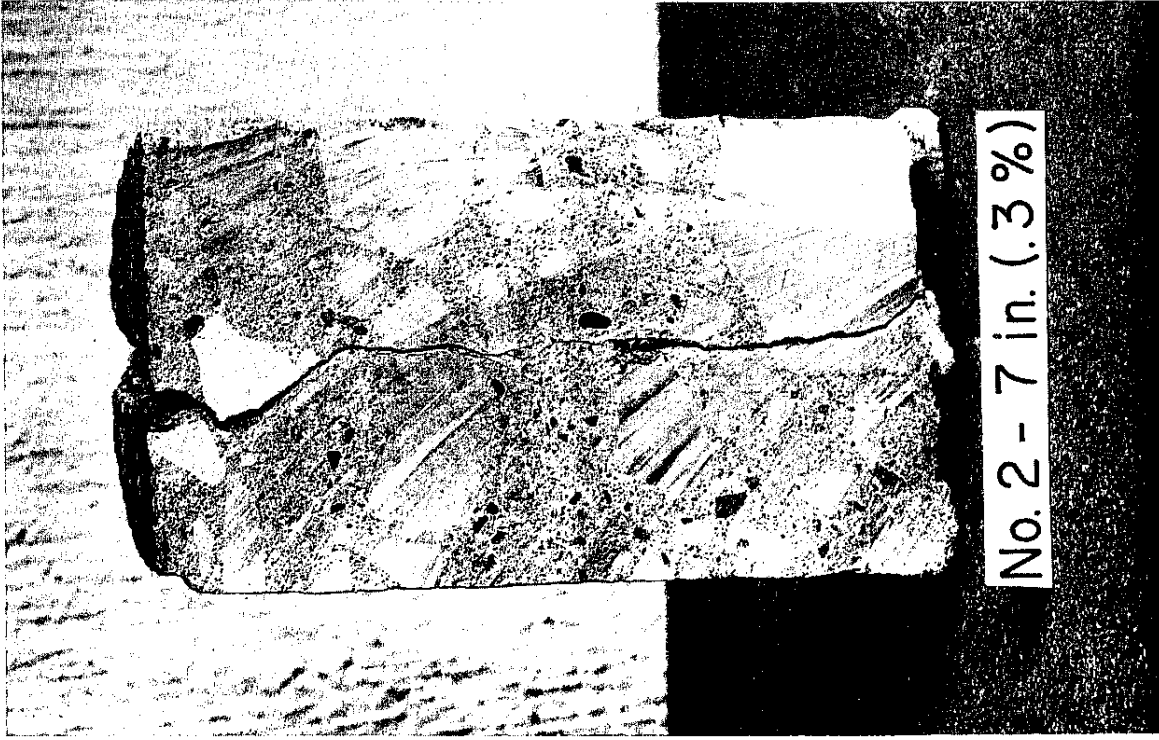
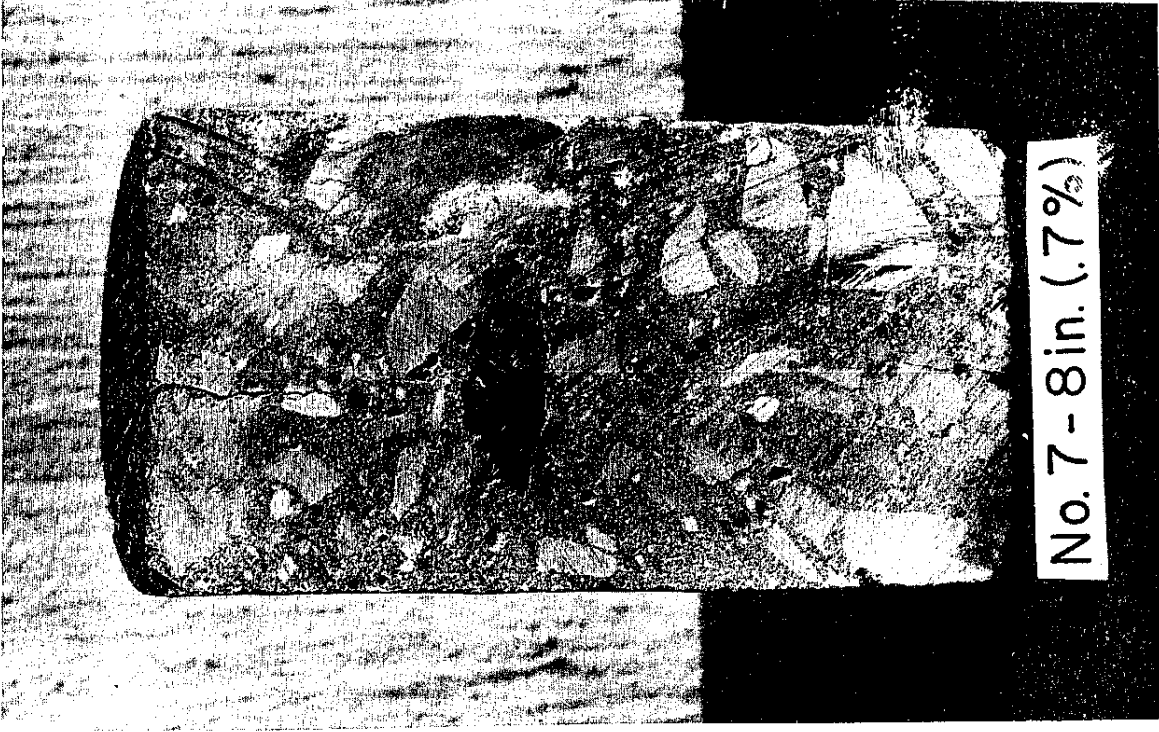
Photographs of cores taken through typical transverse cracks in the 7-inch sections in 1967 are shown in Figure 7. It is apparent in the photographs that the crack openings become very fine a short distance below the surface, at about the level of the steel reinforcement, and remain fine to the bottom of the pavement. An examination of the cores showed a discoloration of the slab faces at the cracks, indicative of the infiltration of fine material. An examination of the condition of the steel reinforcement in the cores showed only a negligible amount of rusting.

Figure 7. Condition of transverse cracks as seen in cores sawed to expose clean face of concrete.
